TUSCON CONVENTION CENTER (TCC) (Leo Rich Theatre)

Building Location: Church Street Tucson, Arizona

Date of Site Visit: 11/16/06

TUSCON CONVENTION CENTER (TCC) (Tucson Music Hall)

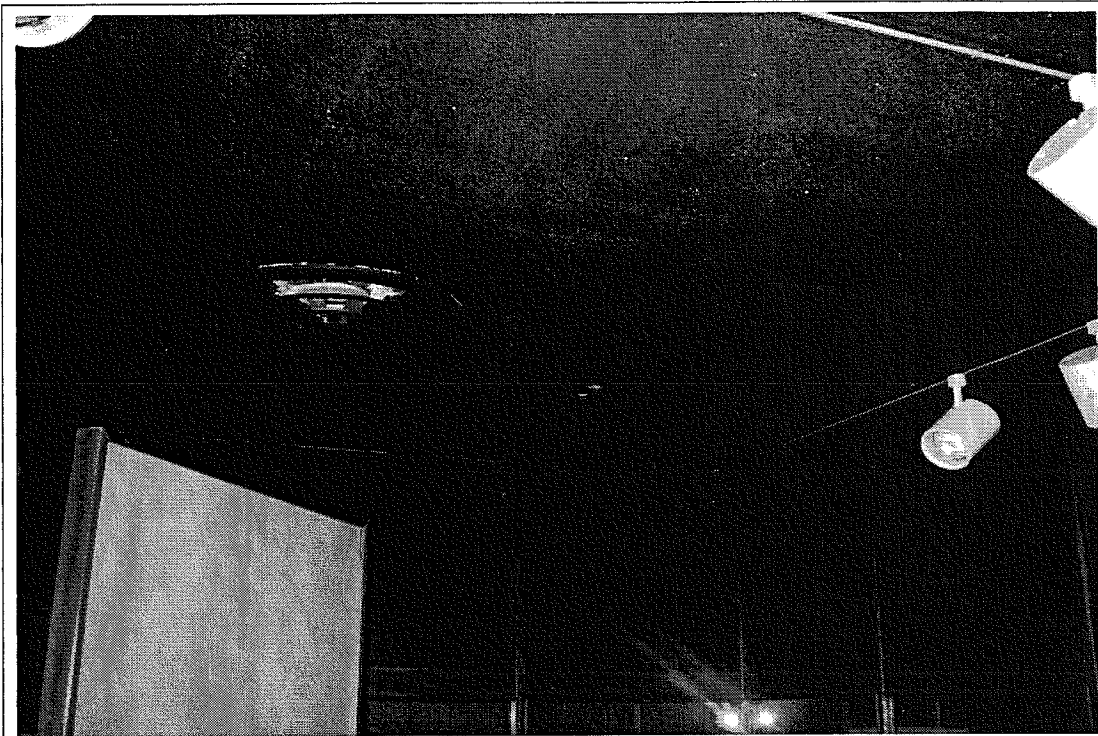
Photo 116. View of black painted acoustical plaster ceiling finish in medicine exhibit (west gallery)

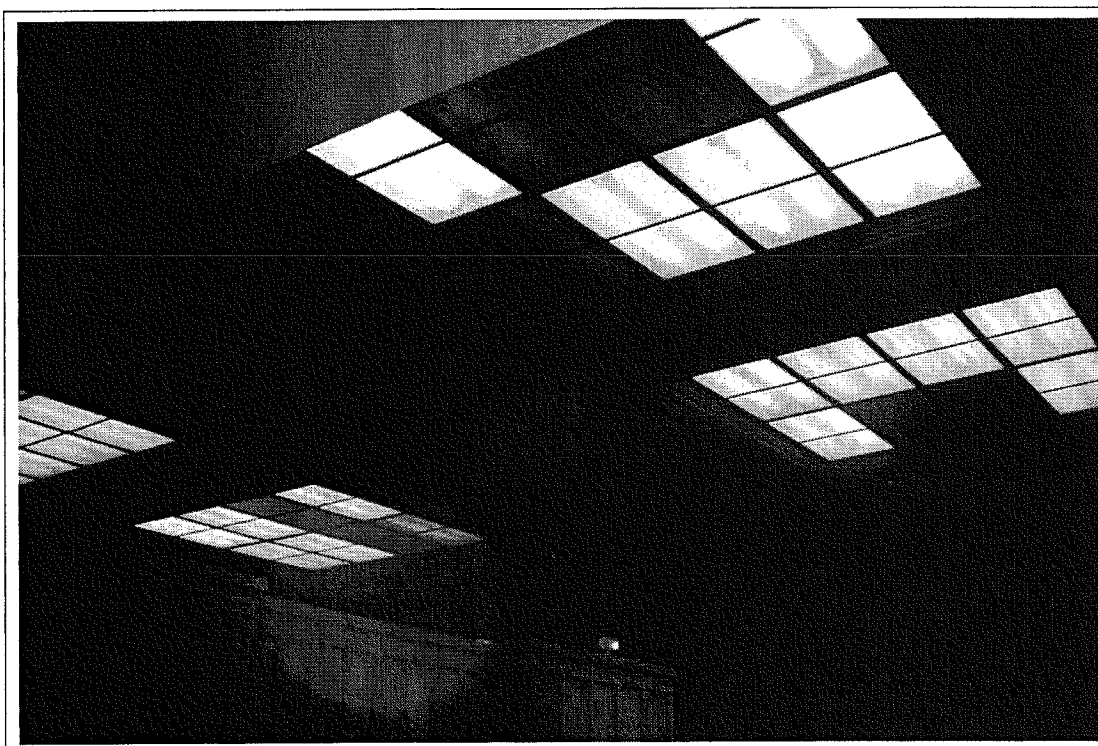
Photo 117. View of acoustical spray finish in main west exhibit gallery (adjacent to lobby)

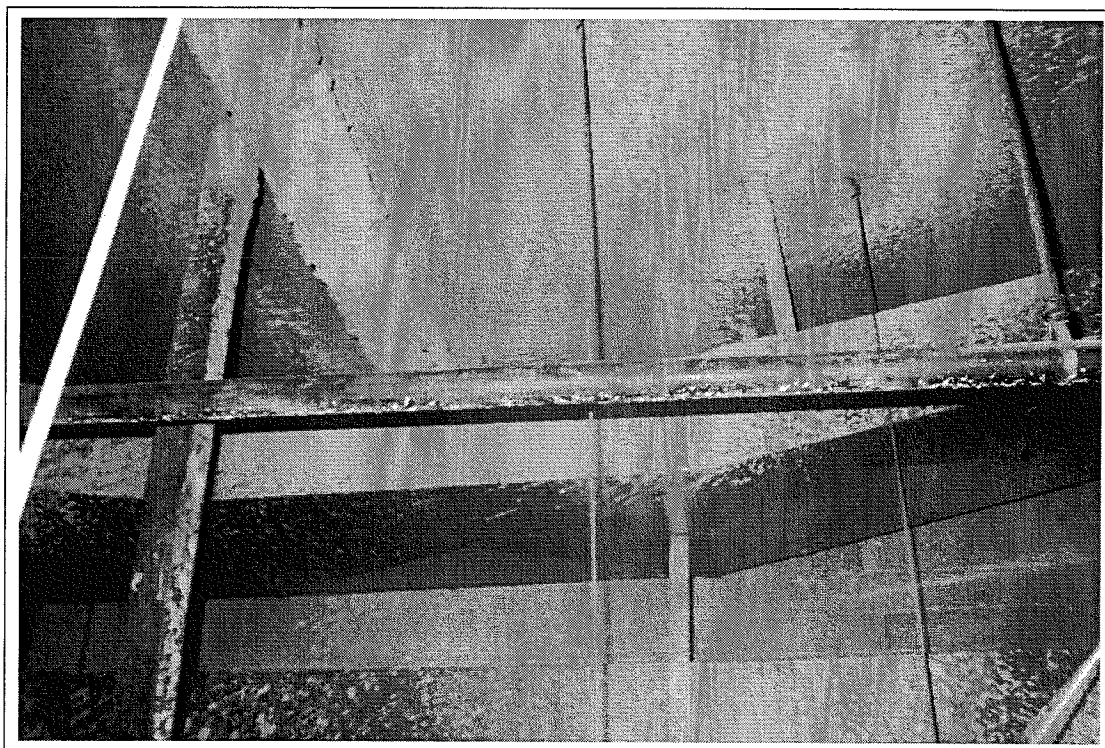
Material Damage: Obvious delamination observed throughout application (evidenced by fireproofing dust, debris and small pea to fist size chunks deposited on horizontal surfaces below deck (including ceiling tiles, duct work and light fixtures).

Damage Assessment: DAMAGED - Approximately 5 to 8% distributed damage with sporadic areas of localized damage (<25%)

Photo 118. View of fireproofing applied to steel I-beams and overspray on decking – above Men's restroom in front lobby (north end)

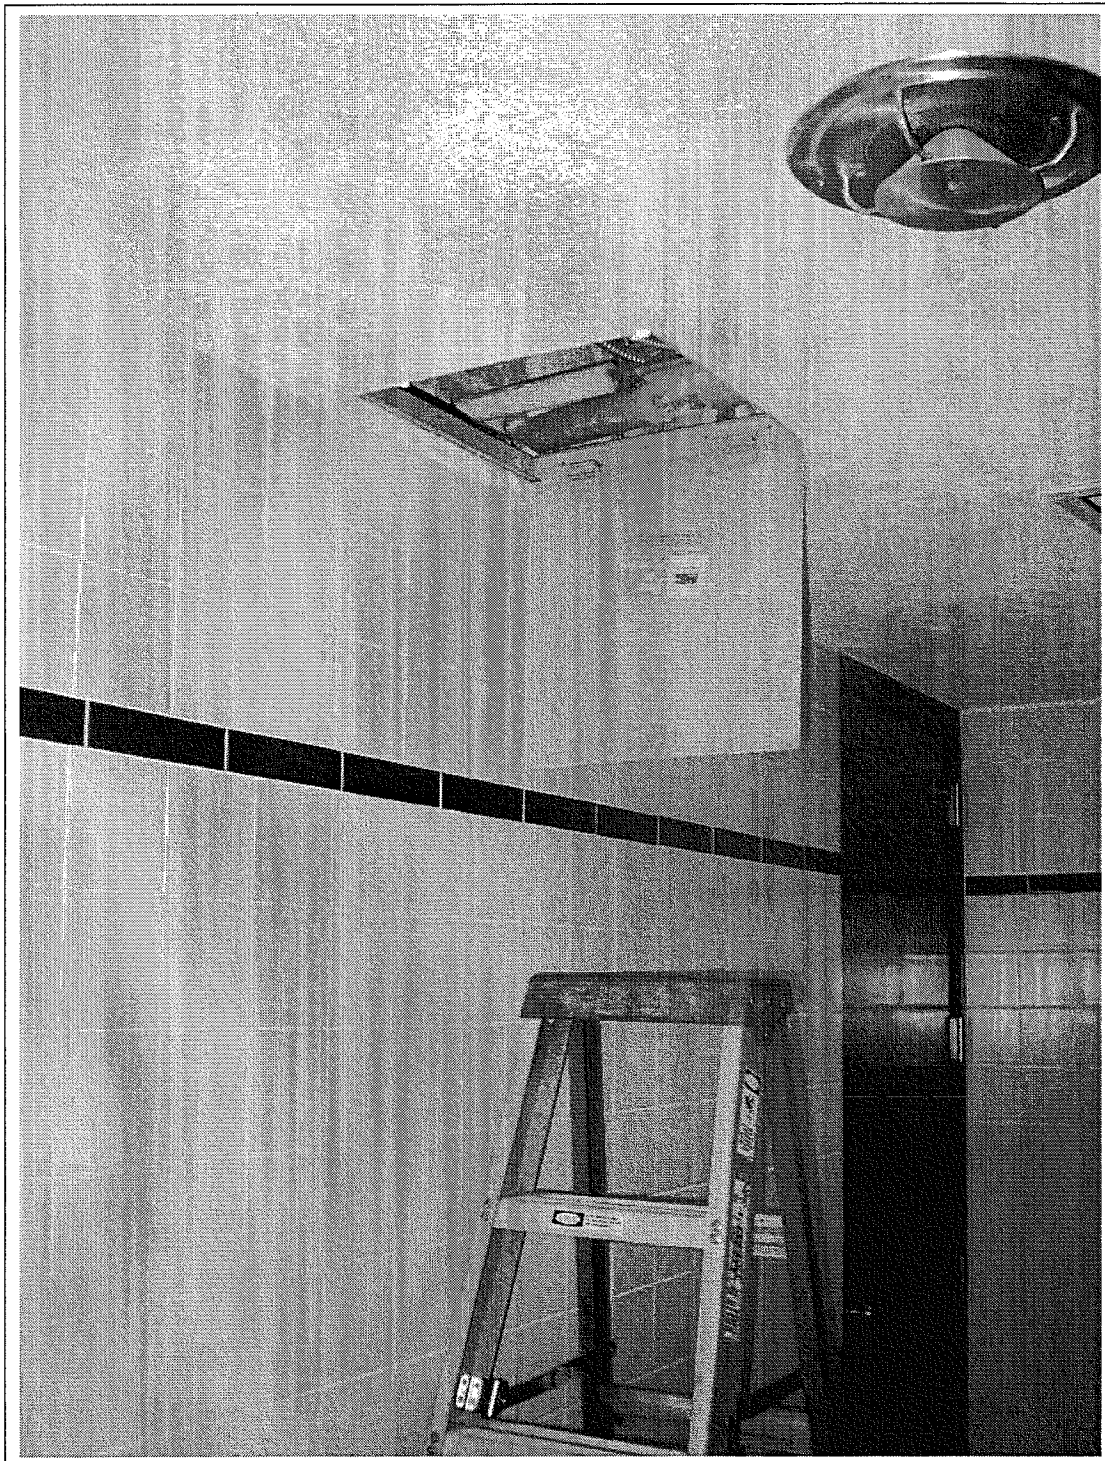
Fireproofing located above plaster ceiling areas is accessible only thru locked ceiling hatches.

Photo 119. View of access hatch to plenum space containing fireproofing in Men's restroom – North lobby area

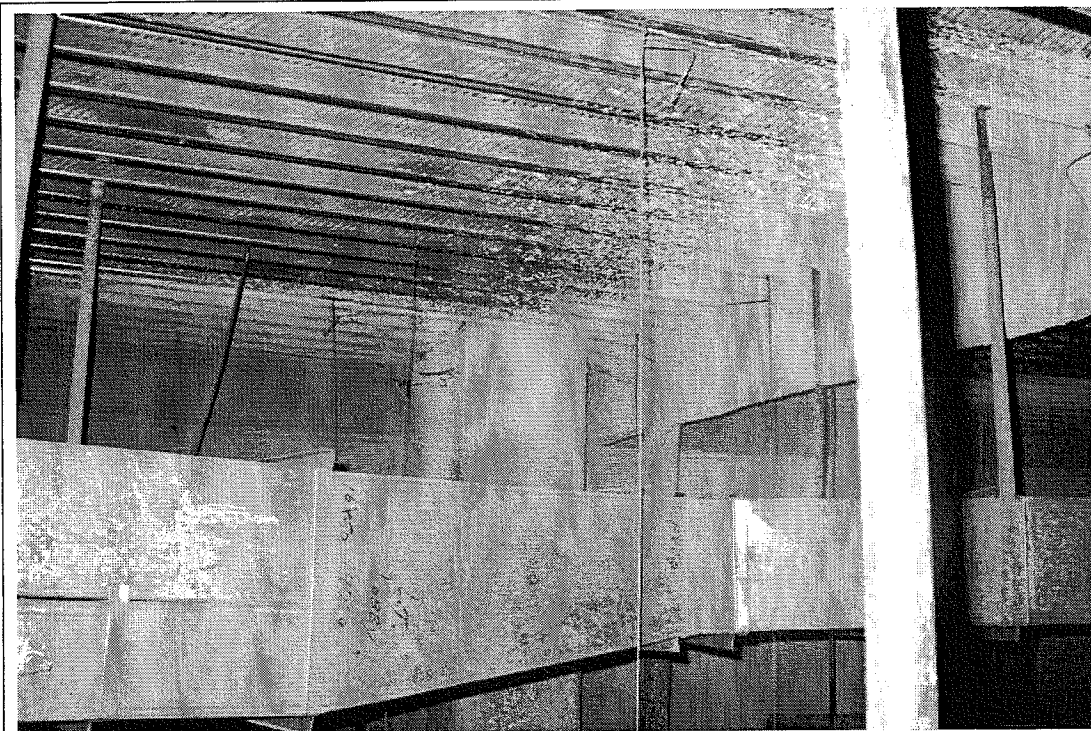
Current Material Condition: Fair Overall – fireproofing generally appears to be substantially intact, however fine dust and debris are visible on most horizontal surfaces.

Photo 120. General view of fireproofing on steel I-beams and overspray on corrugated metal pan decking, hangers and piping located in the attic space above the front lobby

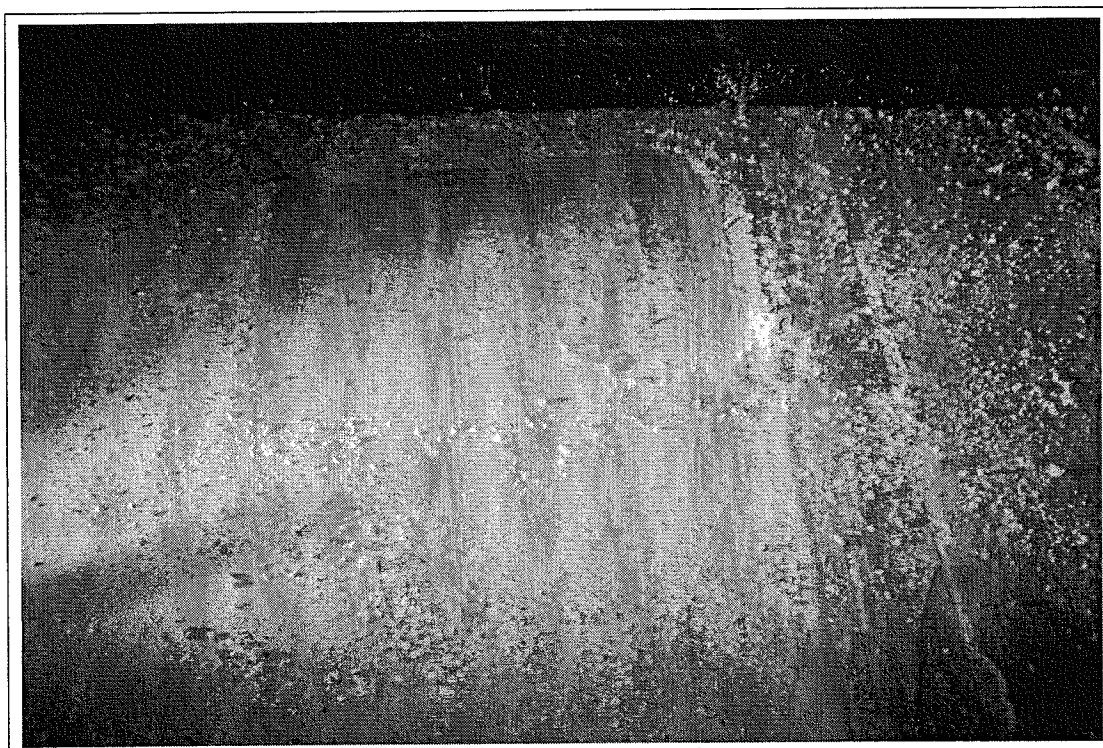
| Sample # | Sample Date | General Sample Location | Sample Surface | Asbestos Structures Counted | Asbestos (Conc.) Str/Ft ² | Asbestos (Conc.) Str/Cm ² | Relative Contamination Level |
|---|---|--|---|---|---|---|---|
| 2 | 11/16/2006 | Tucson Community Center, attic above front lobby | Top of suspended ceiling tile | 112 | 8.40x10 ¹⁰ | 8.40x10 ⁸ | Extreme |

Photo 121. Location of dust sample #2 (top of gypsum board ceiling tile) located above elevated lobby in attic space

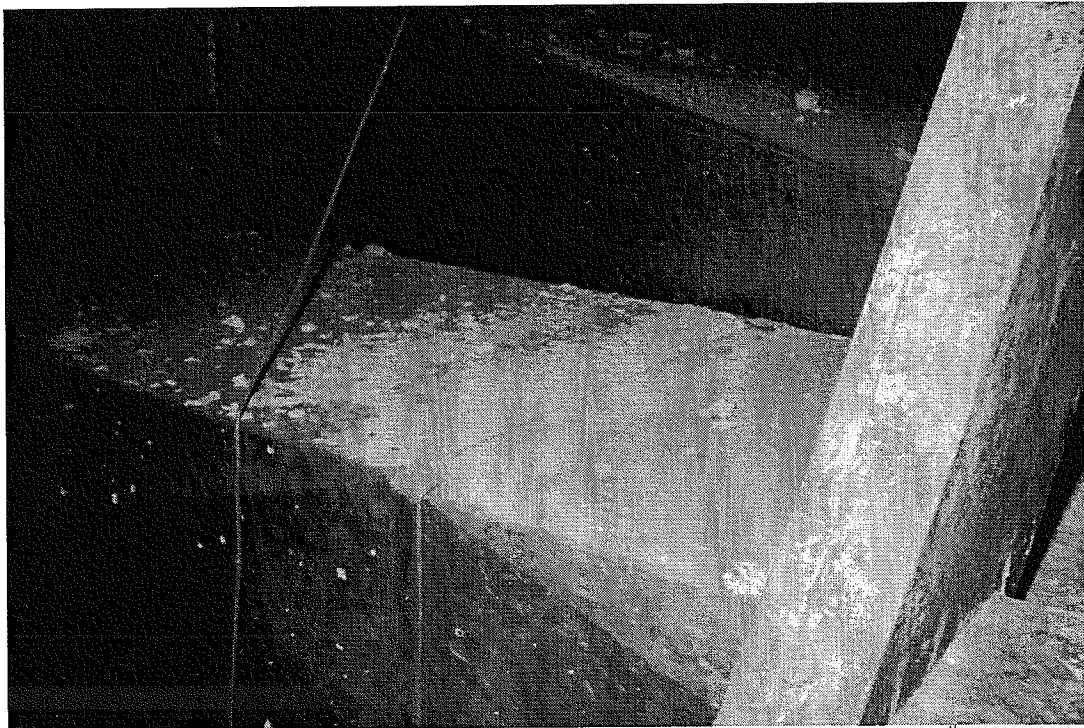
Material Damage: Obvious delamination observed throughout application (evidenced by fireproofing dust, debris and small pea to fist size chunks deposited on horizontal surfaces below the beams and deck (including cat walks, fiberglass batt insulation and HVAC equipment).

Photo 122. View of delaminated fireproofing debris on top of HVAC duct in 5th floor attic

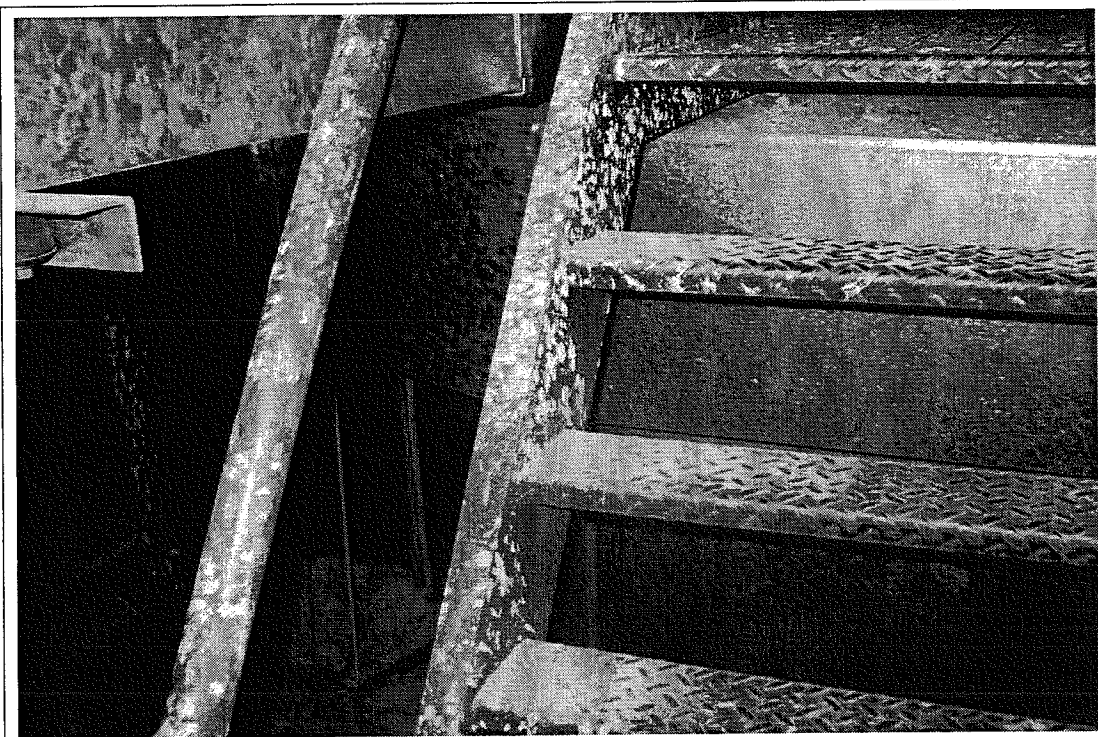
Current Material Condition: Fair to Poor Overall – fireproofing generally appears to be substantially intact, however fine dust and debris are visible on all horizontal surfaces. Fireproofing overspray is highly deteriorated as it covers the catwalks and is impacted and disturbed by foot traffic and handrail use.

Photo 123. View of fireproofing overspray on hand rails and steps in 5th floor attic

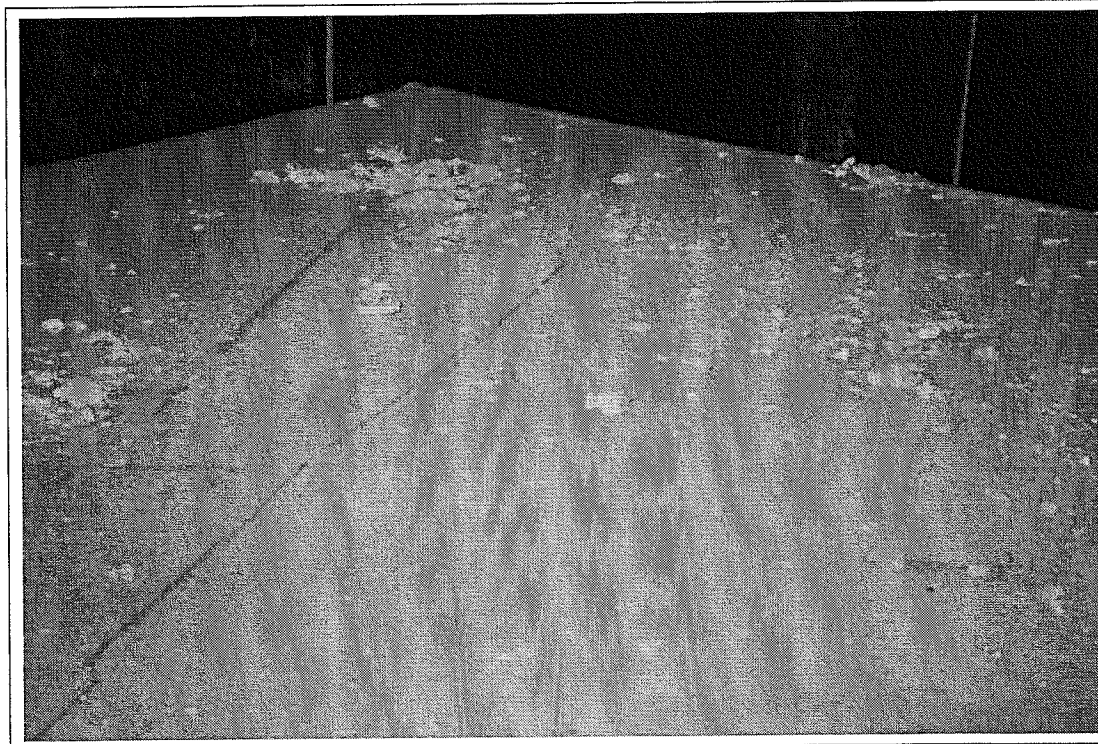
Photo 124. Close-up of delaminated fireproofing debris on top of HVAC duct in 5th floor attic
